Interstate 90 – Snoqualmie Pass East

VISUAL IMPACT ASSESSMENT DISCIPLINE REPORT

September 2004

**Washington State
Department of Transportation**

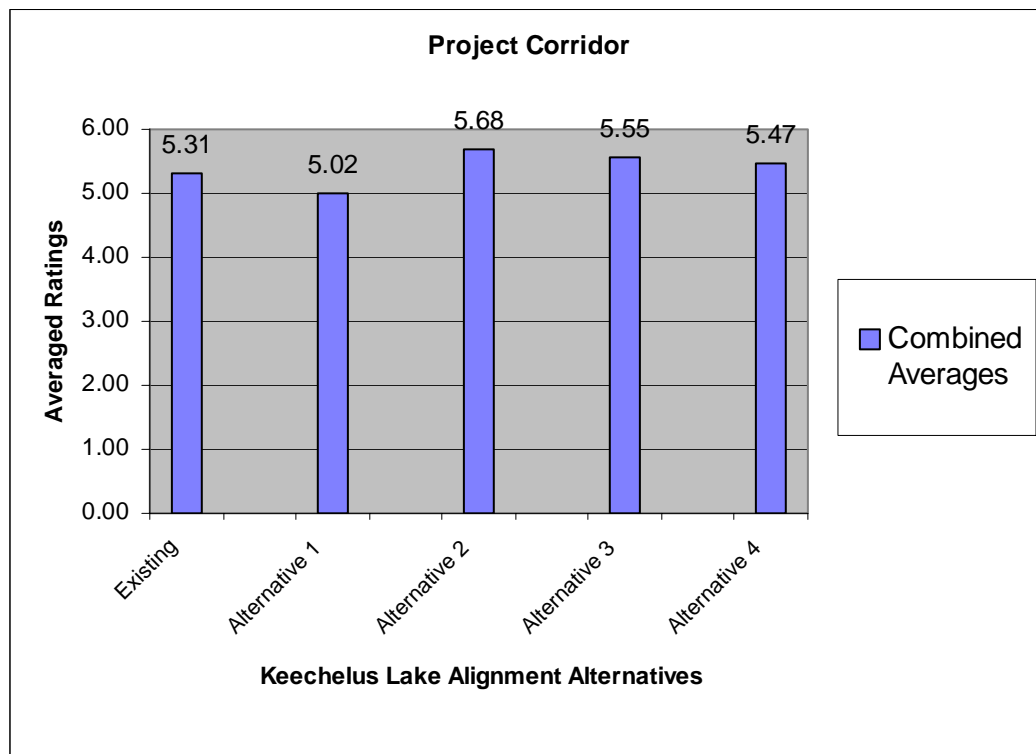
Figure 2 Comparison of Keechelus Lake Alignment Alternatives

These graphs and averages show ratings for all views from and toward the road. They provide a general basis for comparison. Details are found within each Key View description.

For the four Keechelus Lake Alignment Alternatives, Alternative 2: the Short Tunnels alternative has the highest visual quality ratings. The existing roadbed would not be needed if maintenance activities were conducted from the Hyak Maintenance facility, and fewer structures would be needed for ventilation of a smaller tunnel system than for the Long Tunnel Alternative. Alternative 2: the Short Tunnels would remove the road from the sight of viewers across the lake while minimizing the amount of time travelers on the highway would be in a tunnel. While ratings for views toward Alternative 1: Long Tunnels are very high because 1.9 miles of the existing roadbed would be removed, ratings for views from the road are very low for the time the traveler is inside the tunnel. This lowers the overall rating significantly.

Ratings for Alternatives 3 and 4 are very close to one another, and to Alternative 2. Alternatives 3 and 4 both retain I-90, with its views of the lake, around Slide Curve. Alternatives 3, and 4 have larger footprints than Alternatives 1 and 2. This decreases the opportunity for plantings to buffer and screen I-90 from views toward the road. Figure 2 provides a graphic comparison of the total average visual quality ratings for each of the Keechelus Lake Alignment Alternatives compared to the Existing Condition. Only Alternative 1 has ratings below the existing condition because of the views from the road while in the tunnel.

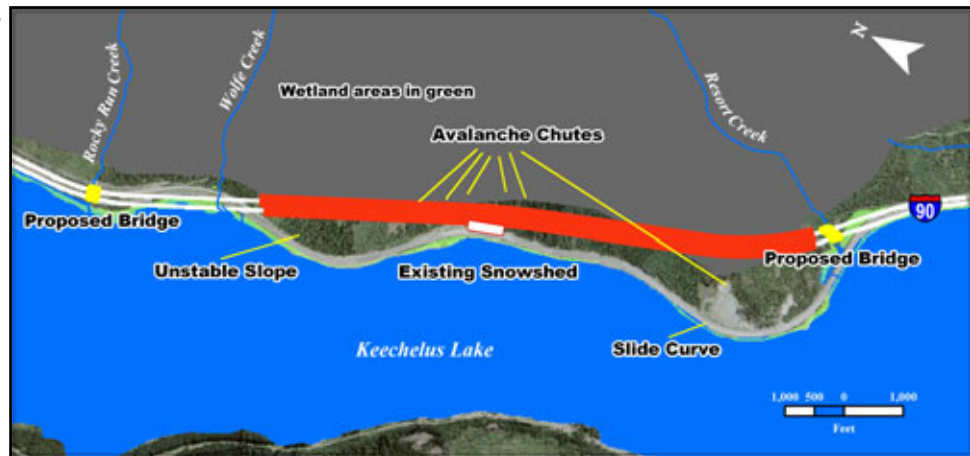
Figure 4 Keechelus Lake Alignment Alternative 1 - Long Tunnel

The first Keechelus Lake Alignment Alternative would construct twin three-lane tunnels for a distance of 1.9-miles (Figure 4). This design completely removes the substandard curves within this section of the Common Route and realigns the interstate to meet 70 mph design standards. Because this alternative bypasses all avalanche zones, it eliminates the potential for accidents, injuries, and road closures from avalanches within this area. It also eliminates the threat of accidents and injuries from rock fall by avoiding unstable slopes. That portion of the existing roadway along Keechelus Lake rendered obsolete by the tunnel would be removed and reclaimed. Because of the Keechelus Lake snowshed's status as an historic feature, coordination with the State Historic Preservation Officer (SHPO) will be required to determine its future.

Because this alternative bypasses all avalanche zones, it eliminates the potential for accidents, injuries, and road closures from avalanches within this area. It also eliminates the threat of accidents and injuries from rock fall by avoiding unstable slopes. That portion of the existing roadway along Keechelus Lake rendered obsolete by the tunnel would be removed and reclaimed. Because of the Keechelus Lake snowshed's status as an historic feature, coordination with the State Historic Preservation Officer (SHPO) will be required to determine its future.

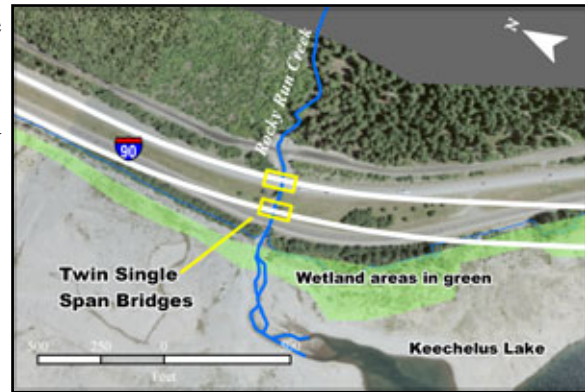
Figure 5 Rocky Run Creek CRA

Rocky Run Creek CRA: Existing conveyance structures at Rocky Run Creek include twin 6-foot corrugated metal culverts at the westbound crossing, and a 100-foot bridge at the eastbound crossing. Twin single-span bridges (approximately 120-feet long) that will provide for fish passage at all reservoir pool-levels are proposed at the Rocky Run Creek CRA.

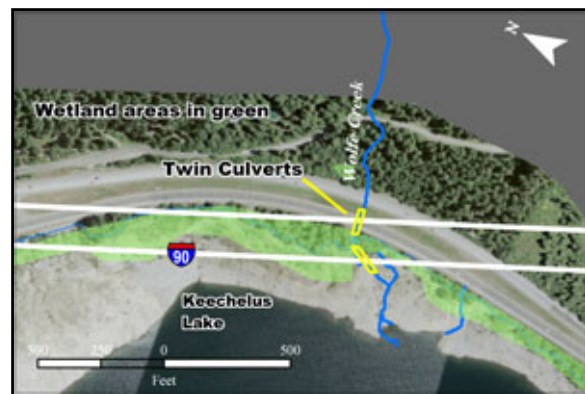
Figure 6 Wolf Creek CRA

Wolfe Creek CRA: Conveyance structures currently in place at Wolfe Creek include a 6-foot corrugated metal culvert under both the west and eastbound lanes. A large-span (10-foot to 30-foot span) bottomless culvert that will provide for fish passage at all reservoir pool-levels is proposed at both the eastbound and westbound creek crossings.

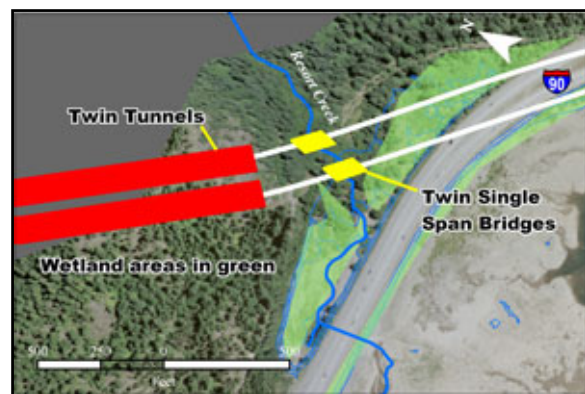
Figure 7 Resort Creek CRA Under Alternative 1

Resort Creek CRA Under Alternative One: Existing conveyance structures at Resort Creek include a 6-foot corrugated metal culvert under both the west and eastbound lanes. This alternative includes constructing twin single-span bridges (approximately 120-feet long) that will provide for fish passage at all reservoir pool-levels.

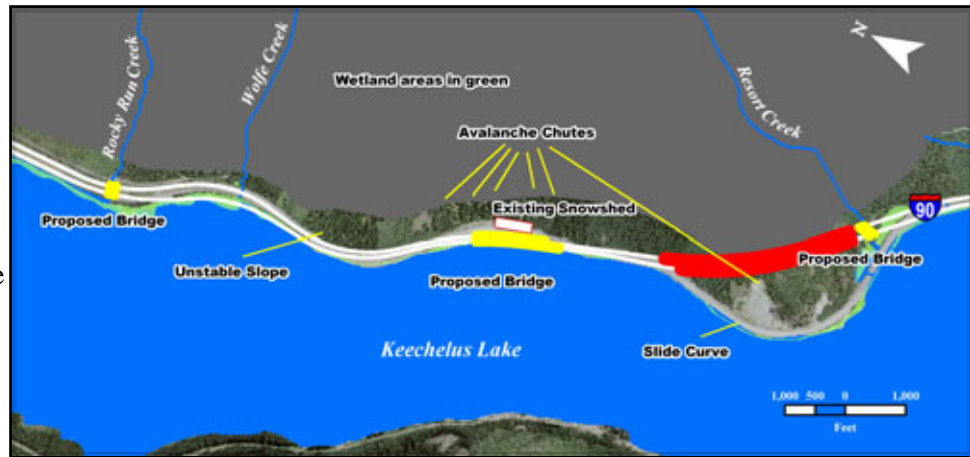
Figure 8 Keechelus Lake Alignment Alternative 2 - Short Tunnels

Keechelus Lake Alignment Alternative 2 would construct twin three-lane tunnels for a distance of 0.6-miles that bypass Slide Curve (Figure 8). This design would straighten the substandard curves from just east of Rocky Run Creek to the snowshed and completely remove the substandard curves at Slide Curve. Realignment of the substandard curves would allow the interstate to meet 70 mph design standards.

Bridges would be constructed over Keechelus Lake in the vicinity of the existing snowshed to convey avalanches under the roadway, significantly reducing the potential for injuries and road closures due to avalanches. Mitigation measures to reduce accidents and injuries from rock fall include slope netting or rock bolting. Because of the Keechelus Lake snowshed's status as an historic feature, coordination with the State Historic Preservation Officer (SHPO) will be required to determine its future.

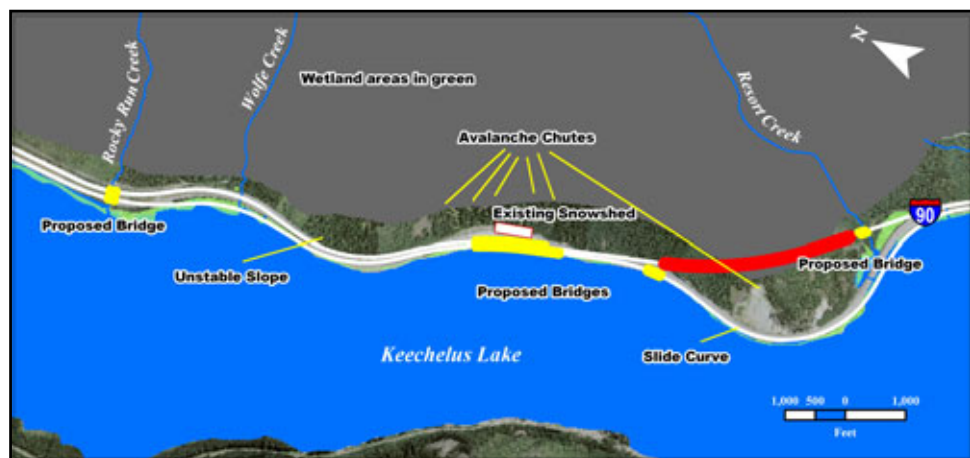
Figure 9 Keechelus Lake Alignment Alternative 3 - Short Tunnel Westbound, No Tunnel Eastbound

Keechelus Lake Alignment Alternative 3 would construct a three-lane tunnel for a distance of 0.6-miles in the westbound direction, and three eastbound lanes that approximate the existing footprint (Figure 9). This design would straighten the substandard

curves from just east of Rocky Run Creek to the snowshed, and remove the substandard curves in the westbound direction at Slide Curve. Westbound lanes would meet 70 mph design standards; eastbound lanes would meet 65 mph design standards. Bridges would be constructed over Keechelus Lake in the vicinity of the existing snowshed to convey avalanches under the roadway, significantly reducing the potential for injuries and road closures from avalanches. Avalanche fencing would be constructed on the slopes above Slide Curve to protect eastbound lanes from avalanches. Mitigation measures to reduce accidents and injuries from rock fall include slope netting or rock bolting. Because of the Keechelus Lake snowshed's status as an historic feature, coordination with the State Historic Preservation Officer (SHPO) will be required to determine its future.

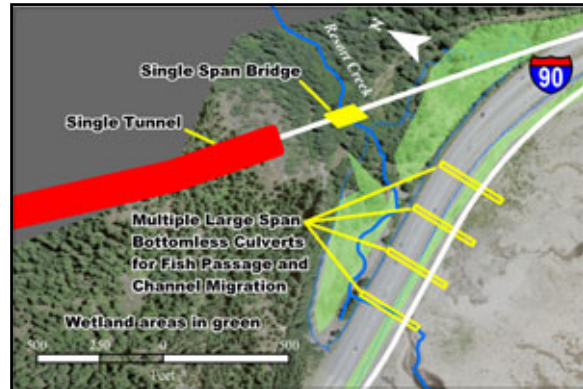
Figure 10 Resort Creek CRA Under Alternative 3

Restoration measures for Rocky Run Creek and Wolfe Creek CRAs within Alternative 3 are identical to Alternative 1. However, the existing 6-foot corrugated metal culverts at Resort Creek would be replaced by a single-span bridge (120-foot long x 10-foot high) in the westbound lanes, and a series of large-span (10-foot to 30-foot span) bottomless culverts in the eastbound lanes that will provide for fish passage at all reservoir pool-levels.

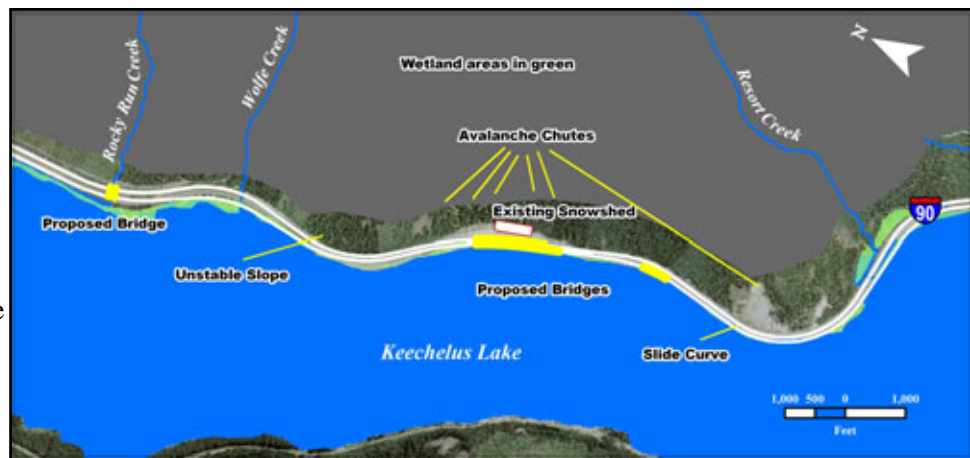
Figure 11 Map of Alternative 4 - No Tunnels, Both Directions of Traffic Along Keechelus Lake

The fourth Keechelus Lake Alignment Alternative would construct three lanes in both the westbound and eastbound directions around Slide Curve (Figure 11). This design would straighten the substandard curves from just east of Rocky Run Creek to the snowshed, but would not remove the substandard curves at Slide Curve. Consequently, both westbound and eastbound lanes would meet 60 mph design standards.

Bridges would be constructed over Keechelus Lake in the vicinity of the existing snowshed that would convey avalanches under the roadway, significantly reducing the potential for injuries and road closures due to avalanches. Avalanche fencing would be constructed on the slopes above Slide Curve to protect both westbound and eastbound lanes from avalanches. Mitigation measures to reduce accidents and injuries from rock fall include slope netting or rock bolting. Because of the Keechelus Lake snowshed's status as an historic feature, coordination with the State Historic Preservation Officer (SHPO) will be required to determine its future.

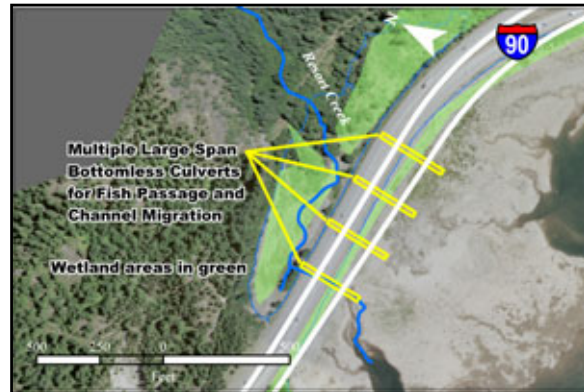
Figure 12 Resort Creek CRA Under Alternative 4

Restoration measures for Rocky Run Creek and Wolfe Creek CRAs within Alternative 4 are identical to alternative 1. However, the existing 6-foot corrugated metal culverts at Resort Creek would be replaced by a series of large-span (10 - 30-foot) bottomless culverts across both the westbound and eastbound lanes.

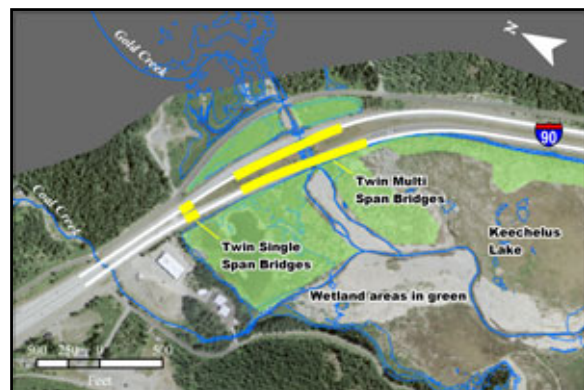
Figure 14 Gold Creek CRA Under Option A

Option A proposes that twin single-span bridges (approximately 120-feet long) be constructed at the western edge of the Gold Creek floodplain. Additionally, two multi-span bridges (approximately 900-feet long in the westbound direction and 1100-feet long in the eastbound direction) would be constructed across the channel migration zone. The bridges would provide a clearance of at least 18 feet. Removal of existing roadbed within the channel migration zone would allow for channel migration, and would help to restore aquatic, riparian, and terrestrial habitat components. The open area provided by these structures would encourage the year-round movement of aquatic, semi-aquatic and terrestrial species. This design option meets the I-90 Mitigation Development Team objectives.

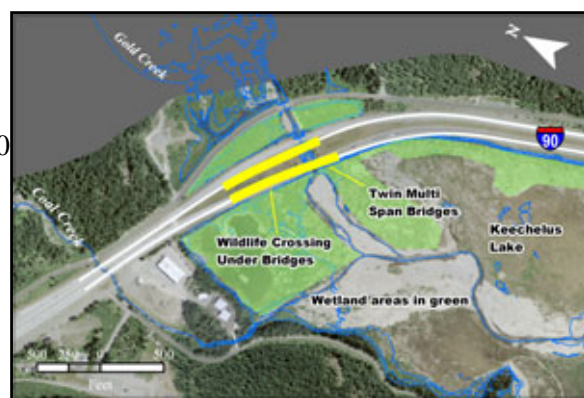
Figure 15 Gold Creek CRA Under Option B

Gold Creek Area Option B: Option B would construct Multi-span bridges (approximately 1,000 feet long westbound and 1,200 feet long eastbound) across Gold Creek's channel migration zone. The bridges would provide a clearance of at least 18 feet. A 100-foot wide terrestrial connectivity bench would be constructed adjacent to the western abutments of both bridges and extend across the northwest shoreline of Keechelus Lake to provide a location for the movement of semi-aquatic and

terrestrial species year-round. The existing road embankment would be removed to allow for normal channel migration, and would help to restore aquatic, riparian, and terrestrial habitat components. This design option meets the I-90 Mitigation Development Team objectives.

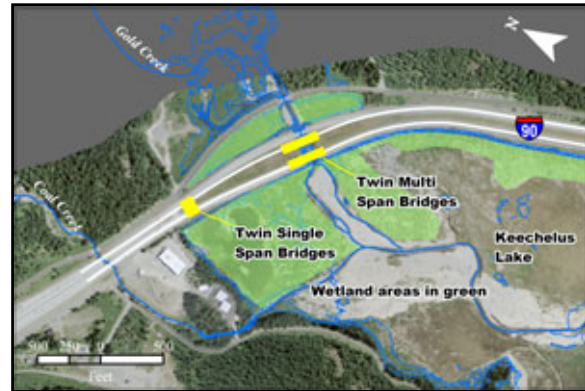
Figure 16 Gold Creek CRA Under Option C

Twin single-span bridges (approximately 120-foot long) would be constructed at the western edge of the Gold Creek floodplain. Both bridges would have a clearance of 12-feet. Twin multi-span bridges (approximately 300-foot long) would be constructed across most of the active channel migration zone. Removal of existing road embankment would increase normal channel migration, and help restore the aquatic, riparian, and terrestrial habitat components. This design option does not currently meet the I-90 Mitigation Development Team objectives, but could if modified further.

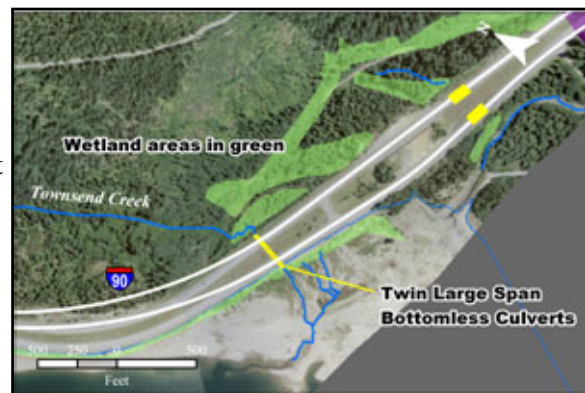
Figure 17 Townsend Creek CRA

Connectivity in the Townsend Creek CRA will be improved by constructing a large span bottomless culvert (10-foot to 30-foot span) that would provide for the movement of aquatic, semi-aquatic, and terrestrial species.

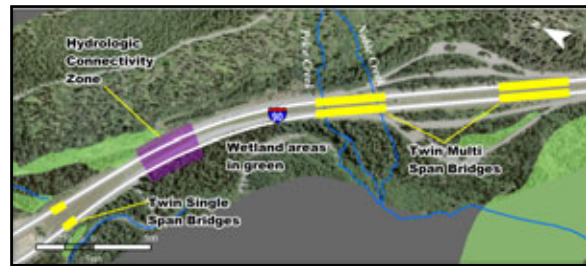
Figure 18 Price/Noble Creek CRAs Under Option A

Under this option, twin single-span bridges (approximately 120-feet long) would be constructed over a draw in the vicinity of MP 60.9, providing at least 18-feet of vertical clearance for the movement of animals through this area. Methods to convey water through the roadbed will be incorporated within the hydrologic connectivity zone in the vicinity of MP 61.0. Twin multi-span bridges (approximately 800-feet long) would be constructed over Price and Noble Creeks. Twin multi-span bridges (approximately 800-feet long) with a minimum vertical clearance of 1-foot would be constructed east of Noble Creek to encourage the movement of both surface and groundwater through the I-90 road prism. The pavement at the Price Creek facility would be removed, and the area would be restored to natural conditions. This design option meets the I-90 Mitigation Development Team objectives.

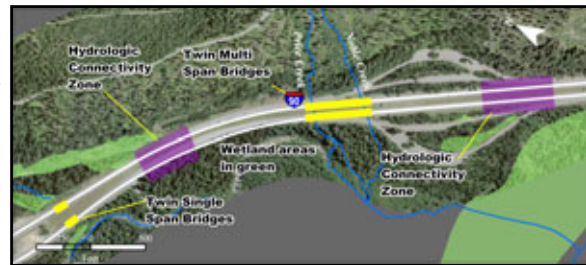
Figure 19 Price/Noble Creek CRAs Under Option B

Option B would construct twin single-span bridges (approximately 120-feet long) over a draw in the vicinity of MP 60.9, providing at least 18-feet of vertical clearance for the movement of animals through this area. Methods to convey water through the roadbed will be incorporated within the hydrologic connectivity zone in the vicinity of MP 61.0. Twin single-span bridges (approximately 800-feet long) would be constructed over Price and Noble Creeks.

Methods to encourage the movement of both surface and groundwater through the I-90 road prism within the hydrologic connectivity zone east of Price Creek will be finalized upon further investigation. The pavement at the Price Creek facility will be removed, and the area would be restored to natural conditions. This design option meets the I-90 Mitigation Development Team objectives.

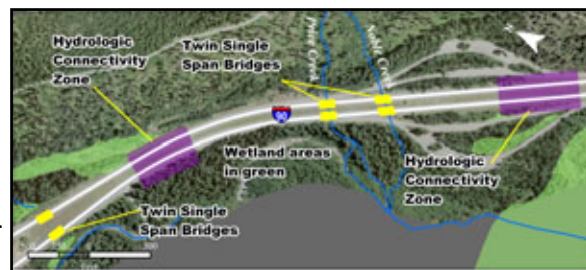
Figure 20 Price/Nobel Creek CRAs Under Option C

Twin single span bridges (approximately 120 feet long) would be constructed over a draw in the vicinity of MP 60.9, providing at least 18-feet of vertical clearance for the movement of animals through this area. Methods to convey water through the roadbed will be incorporated within the hydrologic connectivity zone in the vicinity of MP 61.0. Twin single-span bridges (approximately 120-feet long) would be constructed over Price Creek. Methods to encourage the movement of both surface and groundwater through the I-90 road prism within the hydrologic connectivity zone east of Price Creek will be finalized upon further investigation. The current Sno-park/public restroom facility would remain under this option. This design option does not currently meet the I-90 Mitigation Development Team objectives, but could if modified further.

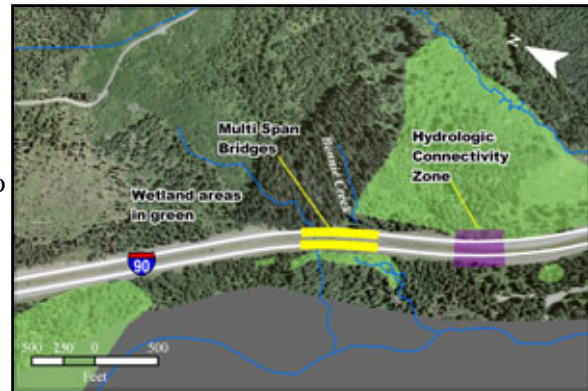
Figure 21 Bonnie Creek CRA Under Option A

Option A would construct twin multi-span bridges (approximately 600-feet long) with a minimum vertical clearance of 20-feet across Bonnie Creek and an unnamed creek 300-feet to the west. Methods to convey water through the roadbed will be incorporated within the hydrologic connectivity zone approximately 500-feet east of the bridge. This design option meets the I-90 Mitigation Development Team objectives.

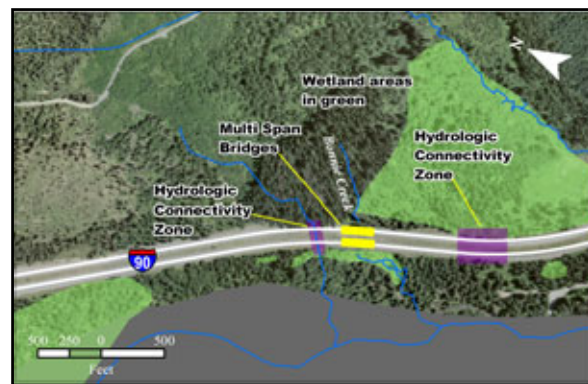
Figure 22 Bonnie Creek Under Option B

Under option B, twin two-span bridges (approximately 250-feet long) would be constructed across Bonnie Creek providing at least 12-feet of vertical clearance for the movement of animals through this area. Methods to promote the movement of both surface and groundwater through the I-90 road prism will be incorporated within the hydrologic connectivity zones approximately 500-feet east of the bridge and at the unnamed tributary west of the bridge. This design option does not meet the I-90 Mitigation Development Team objectives.

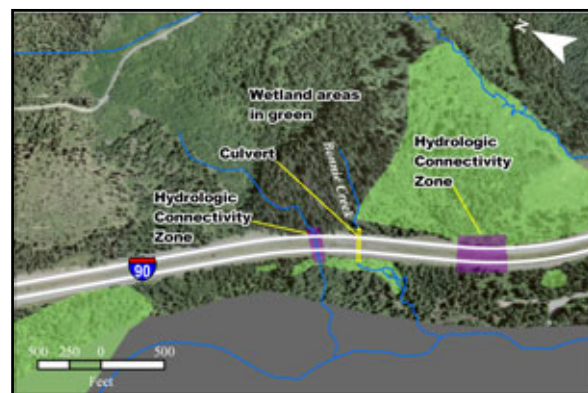
Figure 23 Bonnie Creek CRA Under Option C

Bottomless culverts that provide for fish passage would be constructed over Bonnie Creek. Methods to promote the movement of both surface and groundwater through the I-90 road prism will be incorporated within the hydrologic connectivity zone approximately 500-feet east of the bridge and at the unnamed tributary west of the bridge. This design option does not meet the I-90 Mitigation Development Team objectives.

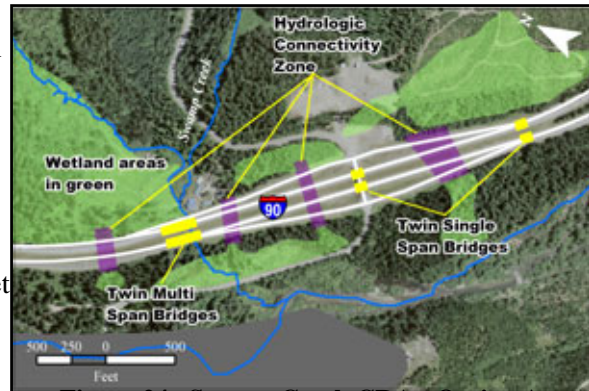
Figure 24 Swamp Creek CRA - Option A

Swamp Creek Area Option A: Twin multi-span bridges (approximately 250-feet long) with a minimum vertical clearance of 15-feet would be constructed over Swamp Creek. I-90 would pass over Stampede Pass Road. Methods to promote the movement of both surface and groundwater through the I-90 road prism will be incorporated within the hydrologic connectivity zones. One set of twin single-span bridges would be constructed in vicinity of the interchange, and another set of twin single-span bridges (approximately 120-feet long) would be constructed at the east end of the interchange. This design option does not meet the I-90 Mitigation Development Team objectives.

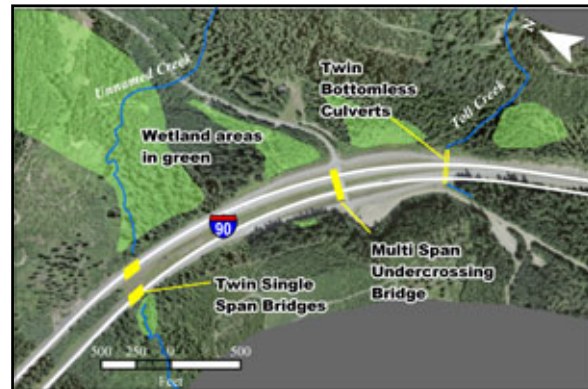
Figure 27 Toll Creek CRA Options A & B

Options A and B would construct twin single-span bridges (approximately 120-feet long) with a minimum vertical clearance of 15-feet at the unnamed creek west of the Cabin Creek Interchange to provide for the passage of aquatic, semi-aquatic, and terrestrial species. Twin bottomless culverts would be installed at Toll Creek that accommodate the hydraulic potential of the stream and permits the passage of debris. These design options meet the I-90 Mitigation Development Team objectives.

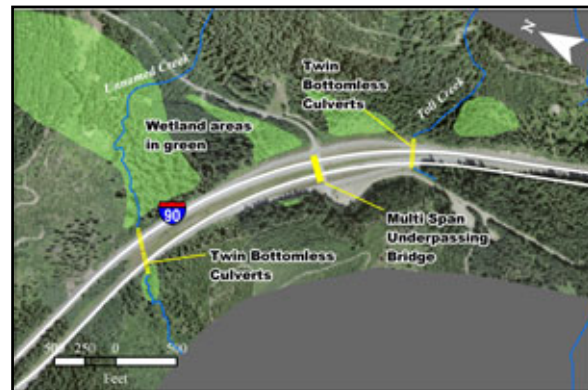
Figure 28 Toll Creek CRA Option C

Toll Creek Area Option C: Under option C, twin bottomless culverts would be constructed at the unnamed creek west of the Cabin Creek Interchange to provide for the passage of aquatic, semi-aquatic, and terrestrial species. Twin bottomless culverts would be installed at Toll Creek that accommodate the hydraulic potential of the stream and permits the passage of debris. This design option does not meet the I-90 Mitigation Development Team objectives.

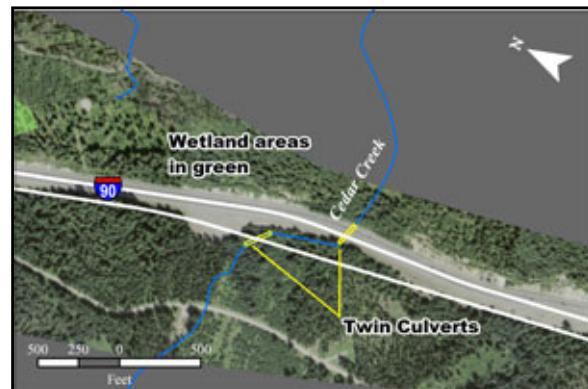
Figure 29 Cedar Creek CRA Option

Connectivity in the Cedar Creek CRA will be improved by constructing two culverts that accommodate stream flow and permit the passage of debris.

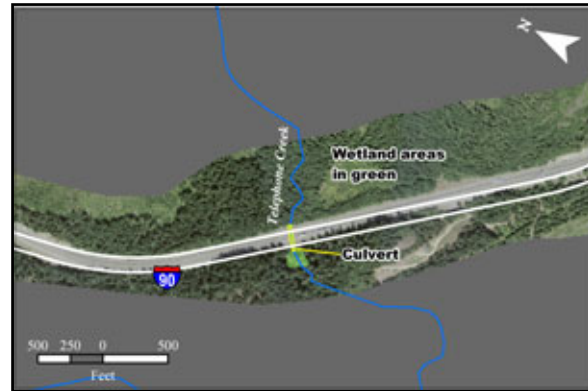
Figure 30 Telephone Creek CRA Option

Connectivity in the Telephone Creek CRA will be improved by constructing a culvert that accommodates stream flow and permits the passage of debris

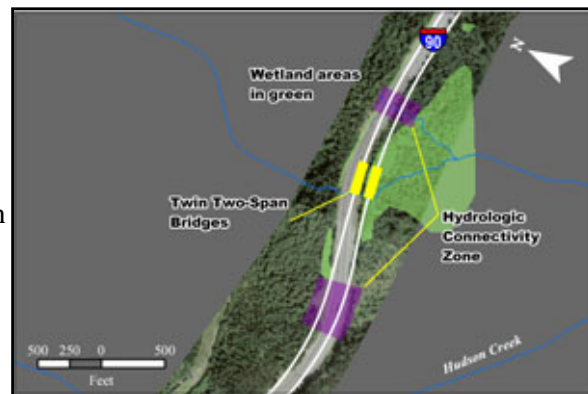
Figure 31 Hudson Creek Vicinity CRA Option A

Option A would construct twin two-span bridges (approximately 230-feet long) that provide at least 10-feet of vertical clearance over a tributary to Hudson Creek. Two hydrologic connectivity zones were identified in this area. Methods for conveying groundwater within these zones will be determined after further investigation and analysis. This design option meets the I-90 Mitigation Development Team objectives.

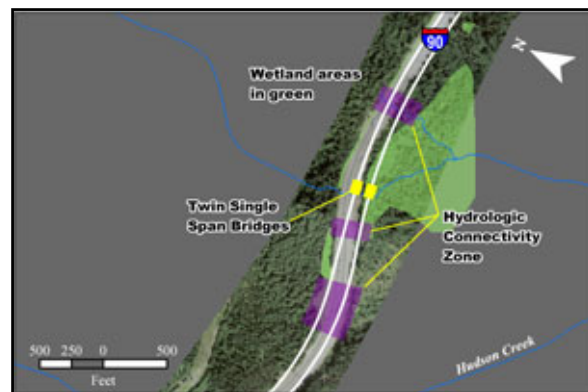
Figure 32 Hudson Creek Vicinity CRA Option B

Option B would construct twin single-span bridges (approximately 120-feet long) that provide at least 10-feet of vertical clearance over a tributary to Hudson Creek. Three hydrologic connectivity zones were identified in this area. Methods for conveying groundwater within these zones will be determined after further investigation and analysis. This design option meets the I-90 Mitigation Development Team objectives.

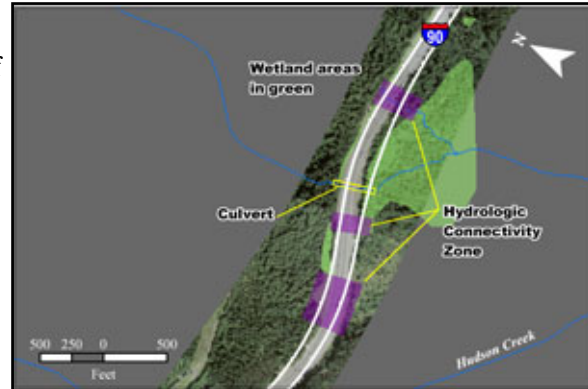
Figure 33 Hudson Creek Vicinity CRA Option C

This option would install a culvert (approximately 4-foot square) at the tributary of Hudson Creek. Three hydrologic connectivity zones were identified in this area. Methods for conveying groundwater within these zones will be determined after further investigation and analysis. This design option does not meet the I-90 Mitigation Development Team objectives.

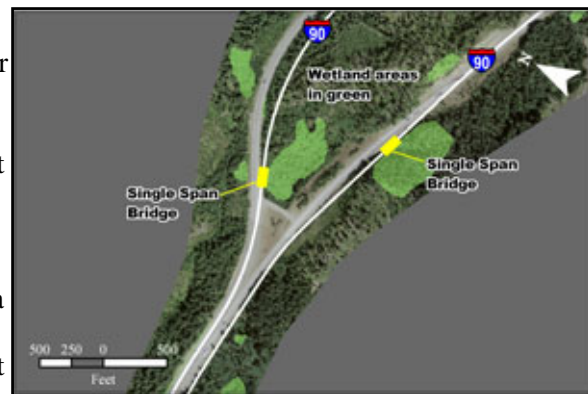
Figure 34 Easton Hill Area CRA Option A

Under option A, the westbound alignment would be reconstructed to accommodate a larger radius curve near the top of Easton Hill. A single-span bridge (approximately 120-feet long) with a vertical clearance of at least 10-feet would be constructed on this new alignment over a draw that holds a wetland complex near MP 67.75. The eastbound alignment would be moved southward approximately 100 feet, and a single-span bridge (approximately 120-feet long) with a vertical clearance of at least 15-feet would be constructed on this new alignment over the draw near MP 67.80. This design option meets the I-90 Mitigation Development Team objectives.

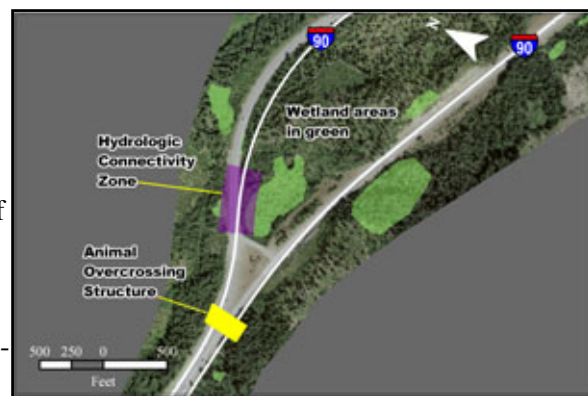
Figure 35 Easton Hill Area CRA Option B

Option B would construct an ecologic connectivity structure over the interstate at MP 67.5. This structure would promote the movement of terrestrial species across the roadway. Methods to promote the movement of both surface and groundwater through the I-90 road prism would be constructed in the westbound lanes near a wetlands complex just east of MP 67.5. This design option meets the I-90 Mitigation Development Team objectives.

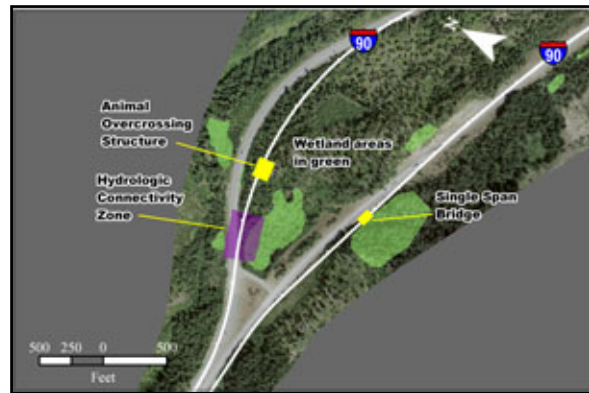
Figure 36 Easton Hill Area CRA Option C

Under option C, the westbound alignment would be reconstructed to accommodate a larger radius curve near the top of Easton Hill. An ecologic connectivity structure would be constructed over the westbound lanes of the interstate at MP 68.0. The eastbound alignment would be moved southward approximately 100 feet, and a single-span bridge (approximately 120-feet long) with a vertical clearance of at least 15-feet would be constructed on this new alignment over the draw near MP 67.80. Methods to promote the movement of both surface and groundwater through the I-90 road prism would be constructed in the westbound lanes near a wetlands complex just east of MP 67.5. This design option meets the I-90 Mitigation Development Team objectives.

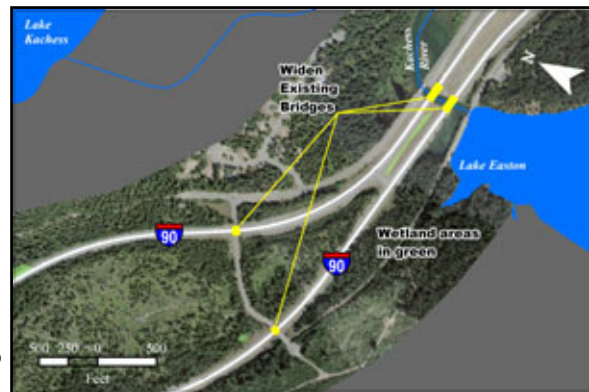
Figure 37 Kachess River Area CRA Option

Kachess River Area Option: This option would widen the bridge over the county road at MP 69.0 to accommodate an additional lane in the eastbound direction. The westbound bridge would be widened or replaced with a bridge of the same length. These bridges would continue to provide for the movement of aquatic, semi-aquatic, and terrestrial species.

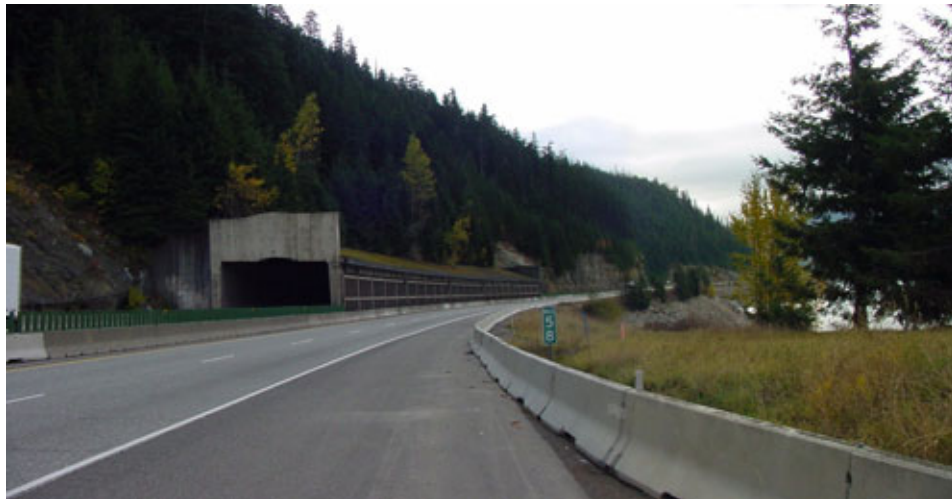
Figure 40 Topography at MP 58 – the Snowshed

The John Wayne Pioneer Trail, a part of the Iron Horse State Park, runs along the western shore of Keechelus Lake and has views toward I-90. There are brief views of the road from Forest Service Road (FS Road) 4832, which runs parallel and above I-90 to the east, in the vicinity of Gold and Rocky Run Creeks. Located off this road are the Gold Creek Sno-park, the Rocky Run Historic Campsite, and summer homes. Currently, concrete barriers form the median between the two lanes of traffic. Figure 40 shows the view at MP 58.

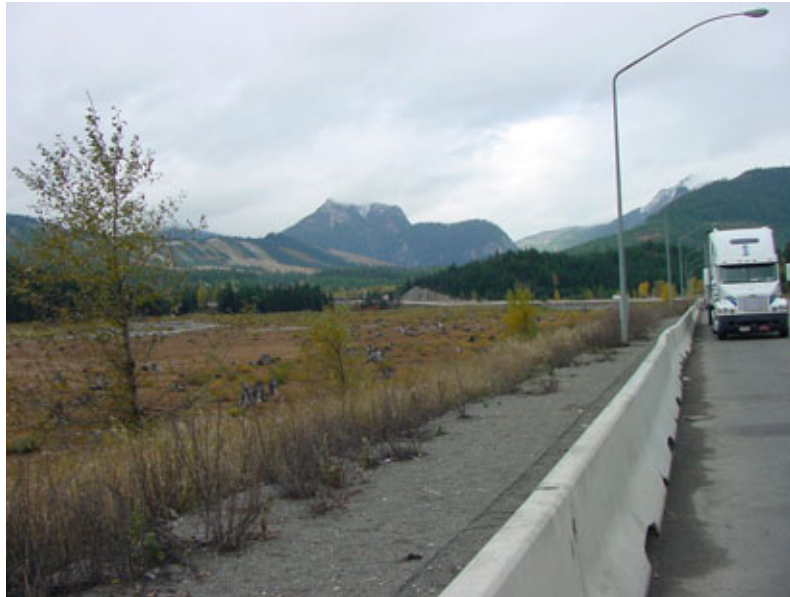
Figure 48 Key View 1 - Westbound MP 56

Key View 1 looks northwest, toward Gold Creek and the ski slopes at Snoqualmie Summit. The existing view, shown in Figure 48 includes the chain-off lanes and lighting provided for that activity. The chain-off area, Jersey barrier and vegetation on the shoulder form the foreground view. Vegetation on the bench above the lake and Gold Creek are in the middleground view. The ski slope and mountains beyond form the background view.

With its view of mountains, ski slopes, and Gold Creek, this area is memorable, especially during the ski season with its lighted slopes for night skiing. This key view has a moderate vividness rating. This view shows that there is some development and that development encroaches to a slight degree. Intactness is rated as moderate. The highway and the cleared areas of the ski slopes interrupt the visual unity of the scene. Overall unity is rated as moderate. Total visual quality for this view is moderately high.

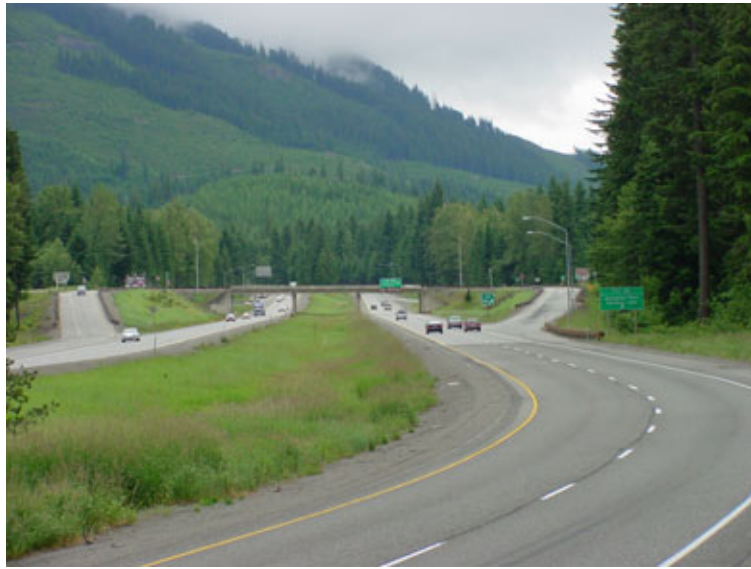
Figure 67 Key View 9 – MP 63.2 – Westbound – Stampede Pass Exit

This Key View shows the Stampede Pass Exit. Foreground views are of the highway and roadside vegetation. Middleground views are of trees and the Stampede Pass interchange. Background views are of trees and the mountain slope.

Total visual quality ratings at this location are moderately high. The bridge over I-90 interrupts the view of the mountains and forest somewhat. There are luminaires on the bridge, and at the ends of the on and off ramps which lower ratings for manmade elements and development.

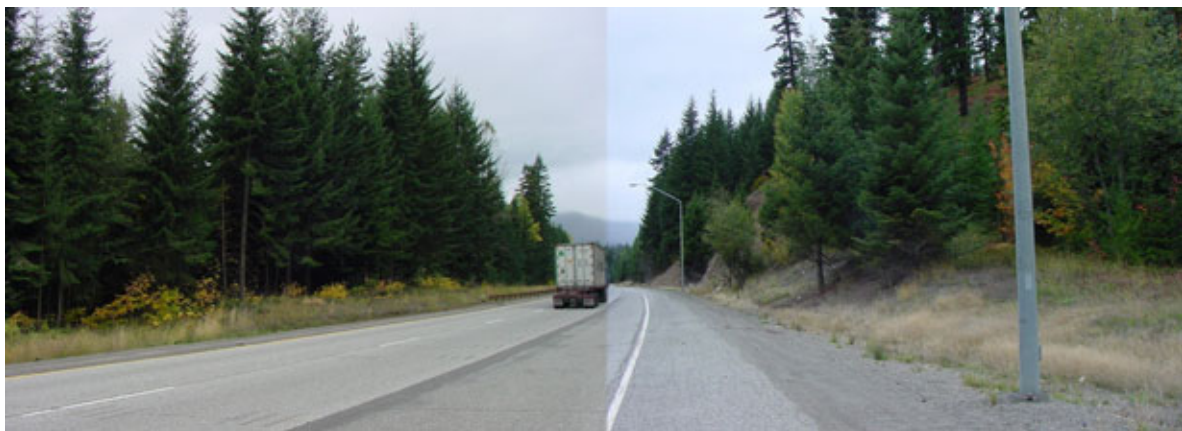
Figure 68 Key View 10 – MP 63.9 – Westbound at End of Cabin Creek Road Onramp

Key View 10, seen in Figure 68, shows the westbound lanes with trees filling the median and enclosing the lanes on the right. This enclosure frames the view to the mountains in the background. Grasses, trees, and light standards form the foreground, as well as the middleground views.

This view has a balance of landform, vegetation, and manmade elements. It has a slightly above average vividness rating. There is some development in the form of the road and lighting, but it encroaches only slightly. The intactness rating is moderately high. The overall unity of the view is moderately high. The total visual quality rating is moderately high.

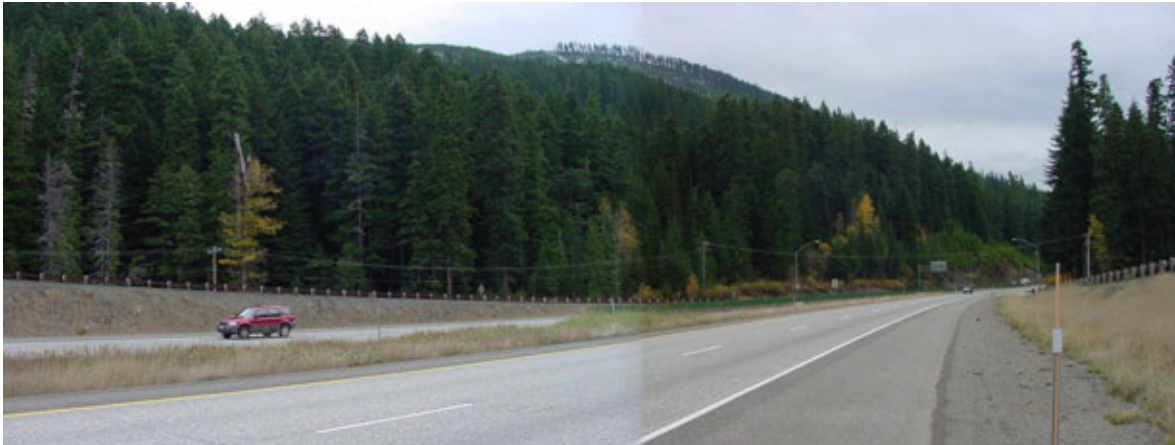
Figure 69 Key View 11 – MP 64.1 – Eastbound – Cabin Creek Road Vicinity

Key View 11 has grass and the roadway in the foreground; the ramps, power lines, and Douglas firs and cottonwoods in the middleground; and logged mountains and sky in the background. There is a stand of mature Douglas firs, seen on the right hand side of Figure 69, just south of the eastbound on ramp from Cabin Creek Road. These trees appear to be over 50 years old and are some of the oldest trees in the project corridor.

This view has a forest stand of moderate age, which provides a sense of enclosure to the road. In this particular view, the mountain in the background provides interest to the scene, which has an average vividness rating. There is some development in this view that encroaches because of the power lines and the sparse tree cover on the logged mountain in the background. Its intactness rating is average to moderate. Because of the encroachment, the unity rating of this view is average. Total visual quality ratings here are average to moderately high.

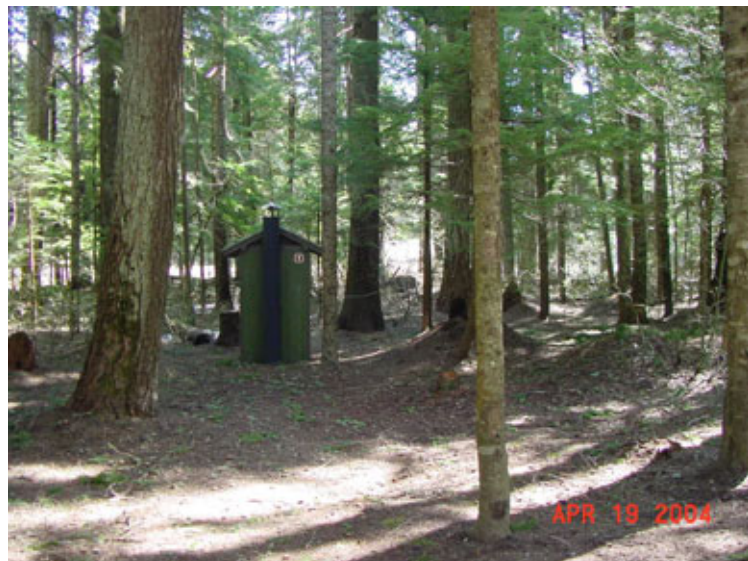
Figure 70 Key View J – Crystal Springs Campground

Key View J is the view from the vicinity of camping space 16 looking toward an outhouse and toward the highway. For the campground, this would be a relatively high use area. The campground is closed during the late fall to late spring months. The photo in Figure 70 was taken in mid-April 2004 while the campground was still closed. I-90 can be seen as the lighter area in the background. The project will not be widening highway in the direction of the campground; however, if there is disturbance, the project will restore vegetation functions in the area within the right-of-way.

There are numerous deciduous shrubs between the campground and the highway that would screen the views during the summer and early fall months. Planting evergreen trees and shrubs along the project edges can increase the screening of the road from the campground. Increased use of evergreen species may help slightly to buffer noise levels, if only psychologically.

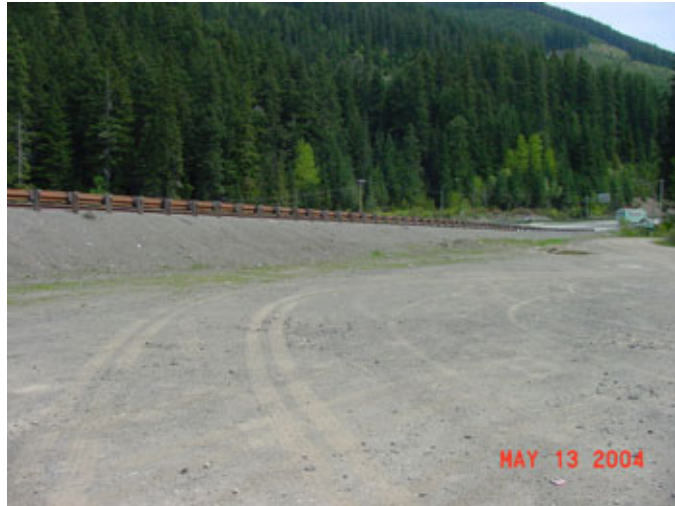
Figure 71 Key View K – Cabin Creek Sno-park

This view has a moderate visual quality rating because of the background views of forest and landform. The view in the foreground of the bare roadway shoulder lowers the vividness, intactness, and unity ratings. This can be seen in Figure 71. Total visual quality ratings at this view are average because of the parking area and bare shoulder.

In the winter when most people see this view, the gravel is covered with snow. At that time, the view would be above average.

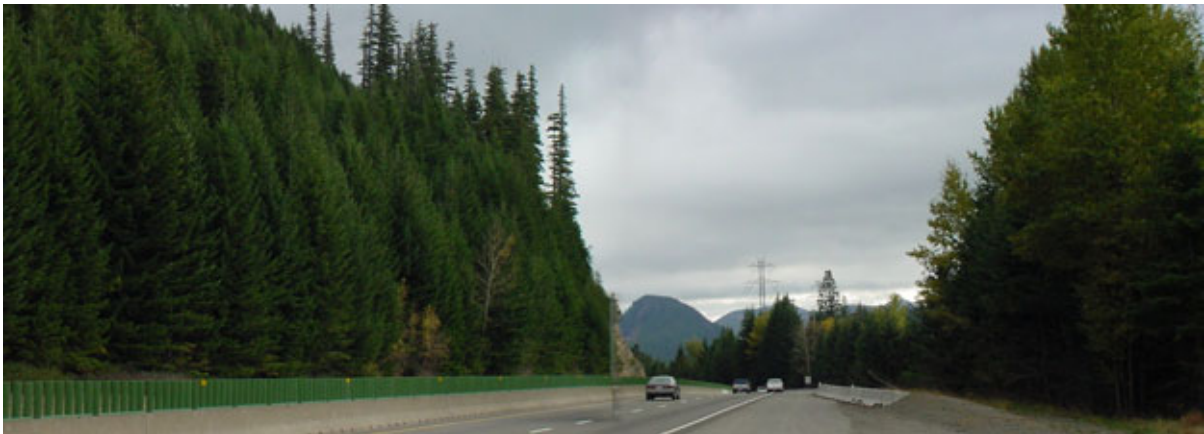
Figure 73 Key View 12 – MP 65.8 – Eastbound

Figure 73, a photo taken from Key View 12, shows Douglas fir and cottonwood trees, the road, and the Jersey barrier median in the foreground. Trees and a transmission tower form the middleground view. Mountains are in the background. The trees screen the majority of the transmission towers and lines from the view of travelers on the road in this location.

Behind the power lines are slopes that have been logged in recent years. Vegetation on these slopes consists of fireweed, vine maple, young cottonwoods, and Douglas fir trees.

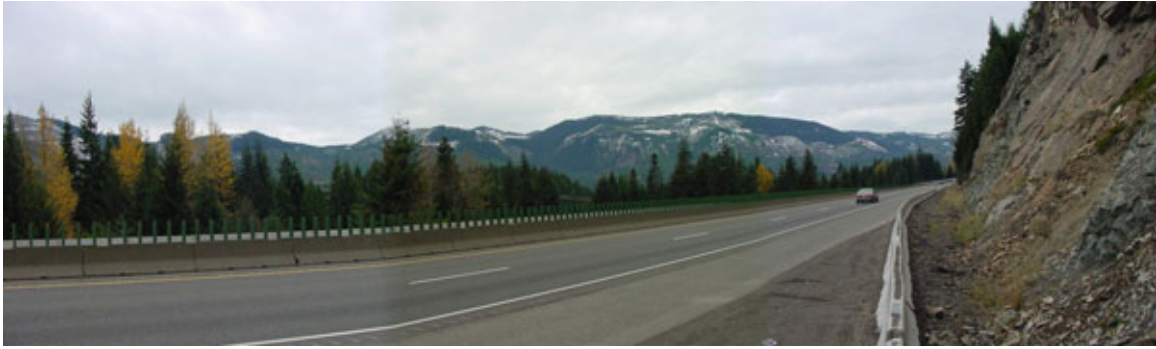
Figure 74 Key View 13 – MP 66.4 – Westbound

The foreground elements in Key View 13, seen in Figure 74, are the rocky slope to the right, the highway, and the Jersey barriers on either side of the westbound lanes. Douglas firs and cottonwoods form the middleground view. There are glimpses of the power lines between the trees in the middleground view. Mountains, which have been logged in places, form the background view.

The mountains visible in the background and the trees in the middleground make this a memorable scene. Its rating is just below average for vividness (because the lack of water in the view lowers the score). There is some development in the scene in the form of the highway and the power lines. Trees screen the power lines except where there are gaps between trees. (Figure 75 shows the power lines behind the trees at MP 66 and is included for information, and was not analyzed as part of this study.) In addition, there are visible logging traces on the mountains in the background. Intactness scores are just above average. Unity in this view is moderately high. Total visual quality rating at Key View 15 is moderately high.

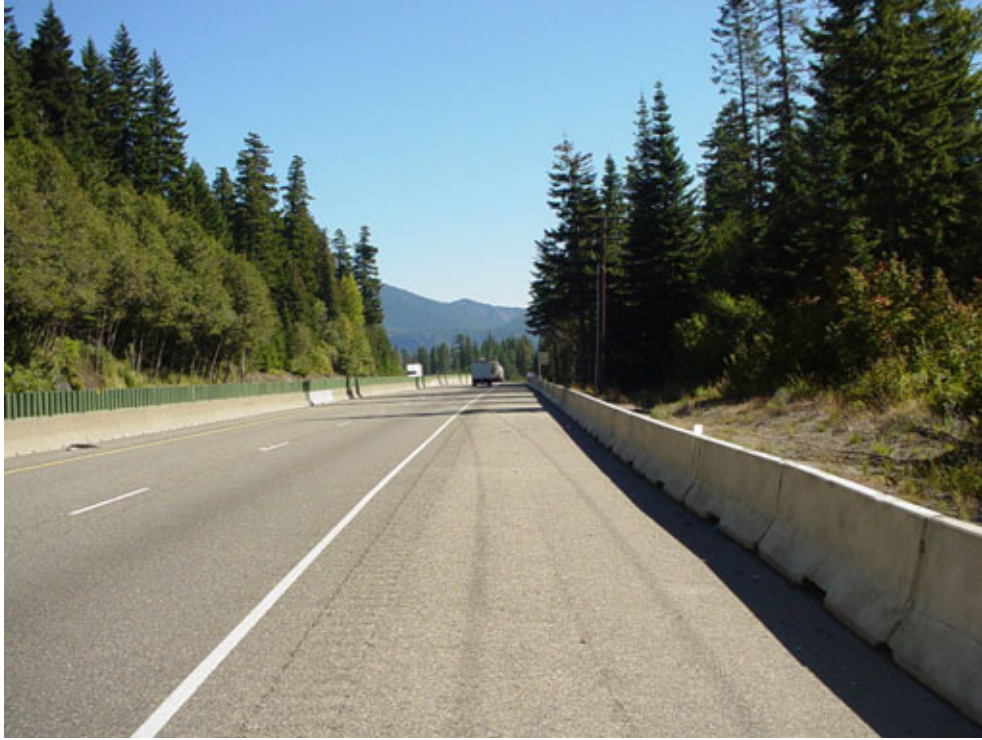
Figure 76 Key View 14 – MP 67.23 – Eastbound

Visual quality ratings are moderately high. The forest encloses the roadway, and forest-covered mountains are seen in the distance, other than I-90 in the foreground, there is little development in the view.

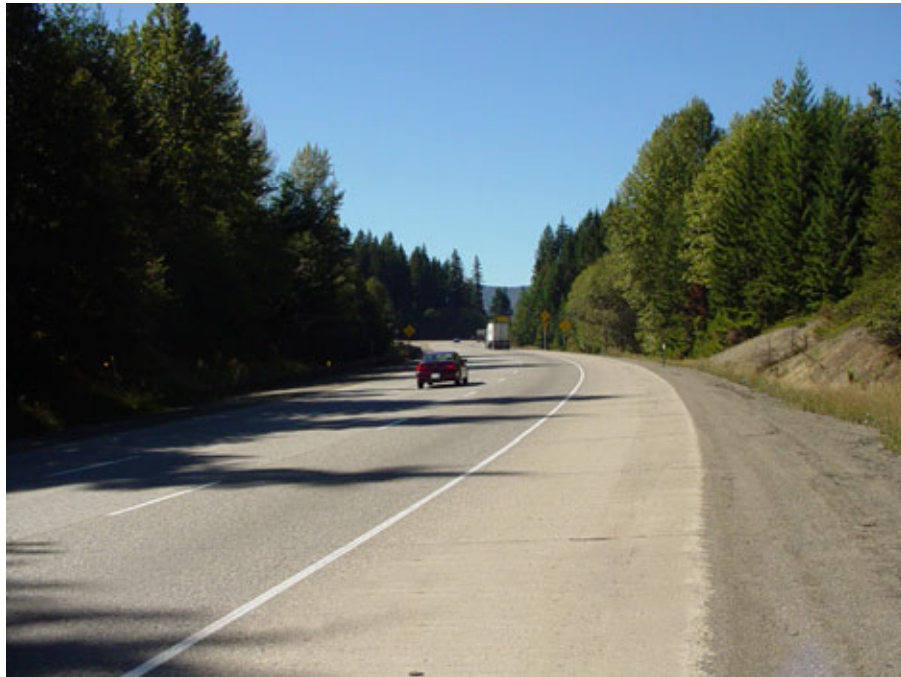
Figure 78 Key View 15 – MP 67.73 – Westbound

This westbound view looks toward the top of Easton Hill. I-90 is enclosed by forest with a wide, heavily forested median. Visual quality in this vicinity is moderately high. Views in the foreground are of the highway. Views in the middleground are of forest, and background views are of forested mountains.
